Investigation of Heavy Vehicle Air Spring Suspension and Load Sharing Characteristics

Arnold McLean¹ and Jason Haddock²

¹University of Wollongong, Wollongong, NSW, Australia

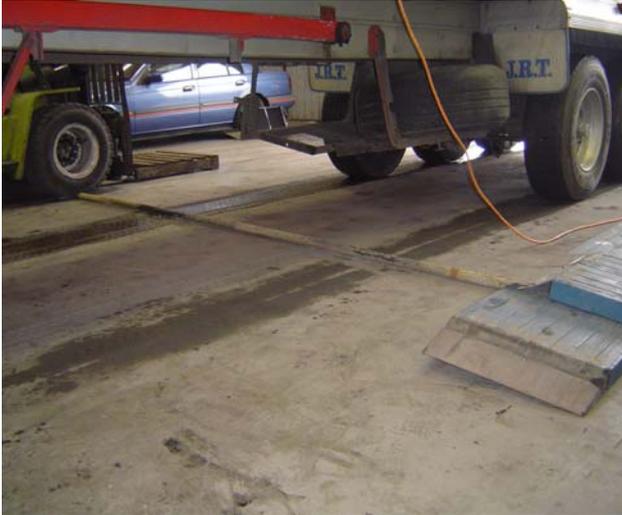
Surface Protrusion: A 6m length of 48.2 mm outside diameter pipe was positioned on a workshop floor. T-pieces were welded to each end to stabilize the pipe (refer Figure 1) when the vehicle's tyres rolled over it. One end of the pipe was also additionally secured by parking a forklift atop the pipe. The pipe's other end was constrained by steel weights.

Figure 1 Pipe used for suspension vertical disturbance input.

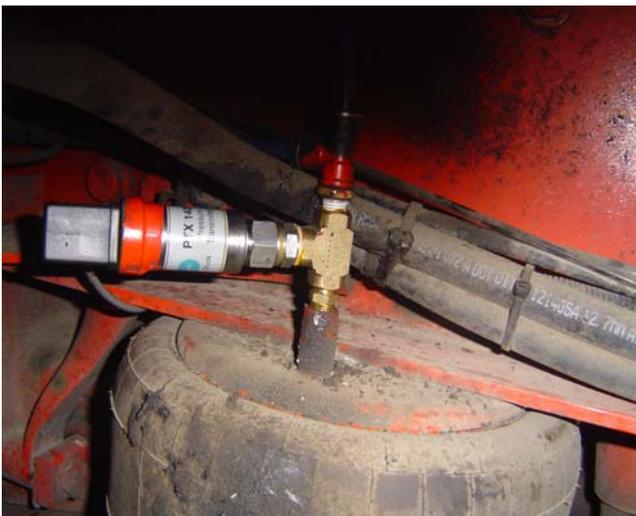
Pressure Transducer: Druck PTX1400 plumbed as close as possible to the front left air spring. The pressure transducer wires were connected to a signal conditioner the output of which was connected to an oscilloscope.

Fittings and Joiners: A 6mm female T-fitting with a 6mm male-male socket was connected along with the pressure transducer and original transmission line connector fitting also attached. Figure 2 depicts the pressure transducer location and plumbing details to the air spring.

Figure 2 Pressure transducer location and plumbing details.

Pressure Transducer Location Where possible the pressure transducer (PT) was fitted as close as possible to the corresponding air spring for both experiments. The drive suspension experiment enabled fitment of the PT relatively close to the air spring. In comparison the cab experiment required a 140mm long length of 6mm air line to be fitted between the PT and air spring. It is estimated, for this relatively low speed test work and low frequency pneumatic system, the pressure transducer adequately 'dynamically' tracked the actual cab air spring pressures.

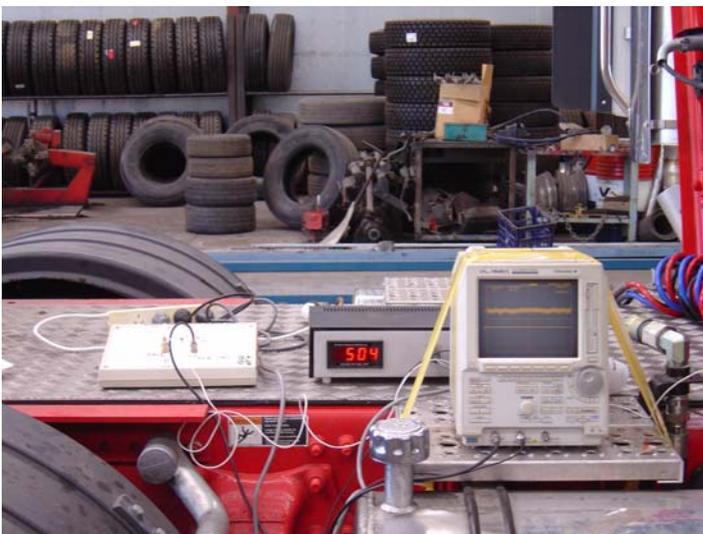
Miscellaneous details and equipment: The oscilloscope, PT and accelerometer and power supplies / signals conditioners were mounted onto the vehicle's walk plate as shown in the following figure, Figure 11.

Figure 11 Instrumentation supply and output setup (RHS).

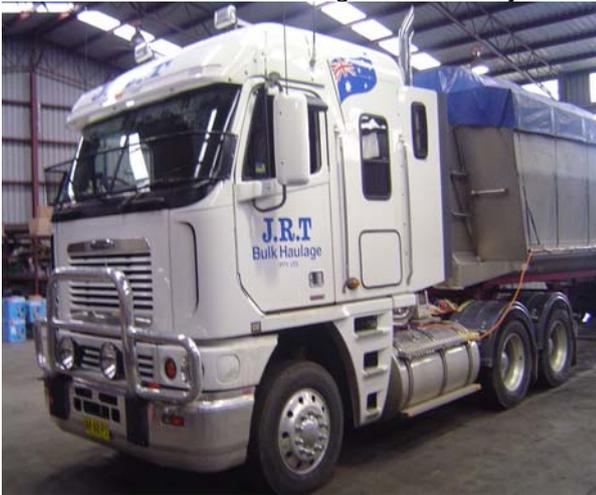
Both of the above tests series were also repeated on the right side of the cab as per the left side. Throughout the tests the equipment was fitted to the corresponding test side. The right side of the cab is essentially a mirror image to that of the left. Figure 12 below depicts the location of the (respective side) step that was mounted and dismounted in this test phase.

Figure 12 Cab step location (LHS).
